CAREFUL LAYOUT TAMES SAMPLE-HOLD PEDESTAL ERRORS

by Anthony D. Wang

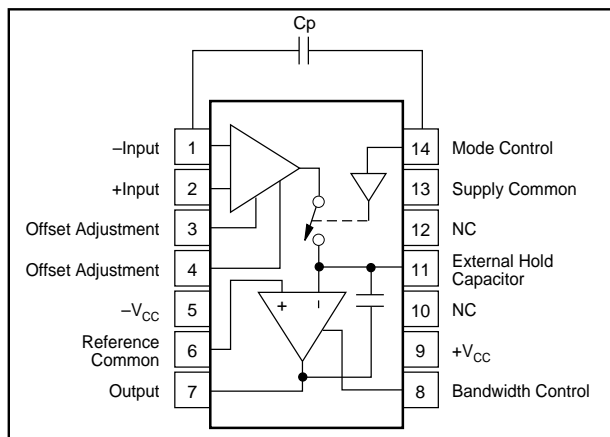
Figure 1 shows the pinout of the SHC5320 with the addition of a parasitic capacitor between pins 1 (inverting input) and 14 (the mode control pin). The inverting input is the closest pin to the digital control signal that is sensitive enough to amplify the parasitic feedthrough.

FIGURE 1. SHC5320 Pinout With C_p , Parasitic Capacitance.

This is a typical coupling path because a convenient layout approach would be to close the feedback loop between the output and the inverting input by routing the trace underneath the device, where it could run too close to the mode control pin.

spaced well away from the mode control line. Ideally, only one of those two traces would route beneath the package. Precautions should also be taken for two other pins that are sensitive to coupling from the digital control pin. These are pins 11 (external hold capacitor) and 8 (bandwidth control).

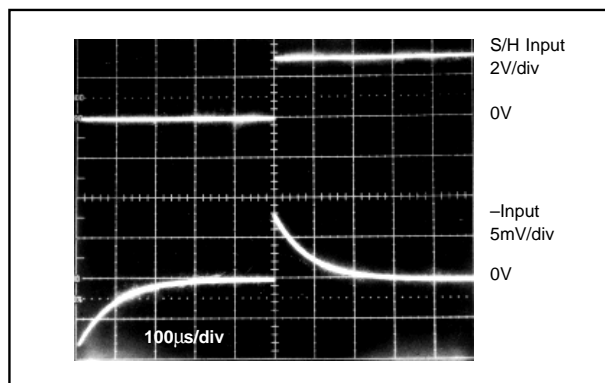
A more insidious parasitic path occurs when sockets are used. Figure 2 shows the signal coupled across an empty socket. The attenuation is roughly 50dB, but can still provide enough of a signal to cause a significant pedestal error. This is suitably documented by the scope photo in Figure 3.

FIGURE 2. Signal Coupling from Pin 14 to Pin 1 for Empty Textool Socket.

The waveforms in Figure 4 confirm that a test board built with the zero profile pin connectors shows no evidence of signal coupling from the digital control pin to the inverting input. The board layout uses the technique mentioned earlier of routing a minimum width feedback trace underneath the circuit. In this example, the socket is empty and the signals are measured just as they were in Figure 2.

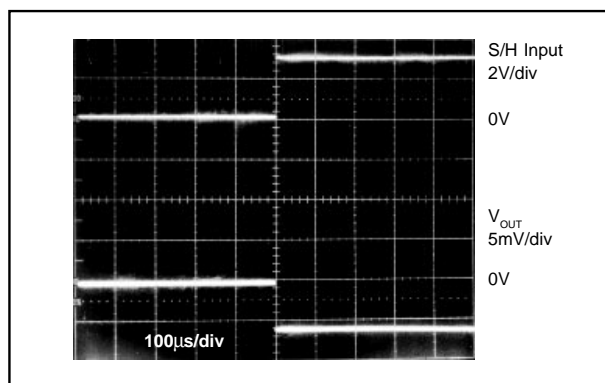
FIGURE 3. Pedestal Error Resulting from the Use of a Textool Socket.

The sample-hold was configured as a unity gain follower with its input grounded. The output trace displays a pedestal error of -6mV . Note that this is a negative excursion due to the rising edge of the digital mode control signal coupling to the inverting input of the sample-hold circuit.

The best way to avoid this is to solder the sample-hold directly into the board. If hard soldering is not a viable option, avoid the use of high profile sockets, especially the zero insertion force type. The optimum approach uses zero profile solderless sockets (such as Augut P/N 8134-HC-5P2).

Figure 5 demonstrates the reward for the attention to detail covered by this discussion. The pedestal is a barely perceptible -0.5mV for the same unity gain configuration and for the same unit as illustrated in Figure 3.

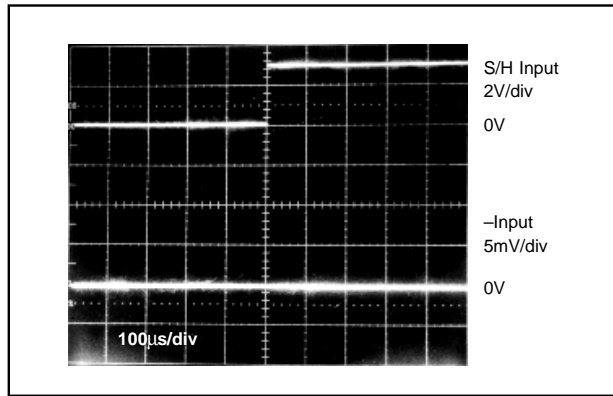
FIGURE 4. Signal Coupling from Pin 14 to Pin 1 for Empty Zero Profile Socket.

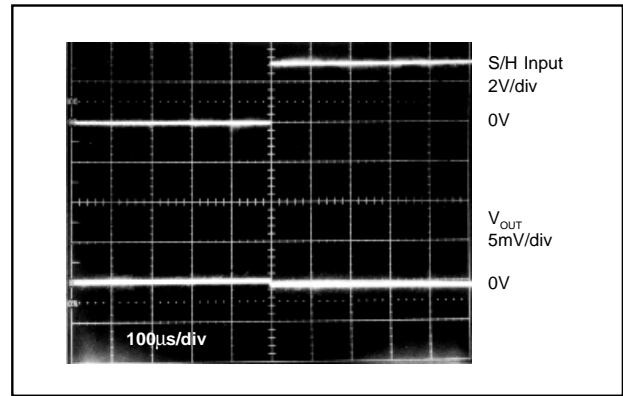
FIGURE 5. Pedestal Error Resulting from the Use of a Zero Profile Socket.
